Affordable hybrid thermography for merchant vessel engine room fire safety

Agata Krystosik-Gromadzińska

West Pomeranian University of Szczecin, Faculty of Maritime Technology and Transport
Department of Safety and Energy Engineering
e-mail: agatak@zut.edu.pl

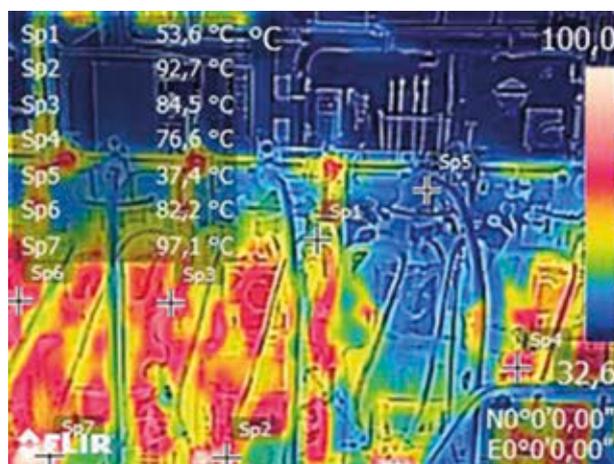
Figure 1 shows an overall view of main engine that was processed with the FLIR Tools software to identify temperature values in spots with the highest temperature as indicated by the camera. The uppermost value was recorded on the fuel injection pumps – Sp2 (92.7°C) and Sp7 (97.1°C).

Figure 1. Main Engine (ME), Thermal Map

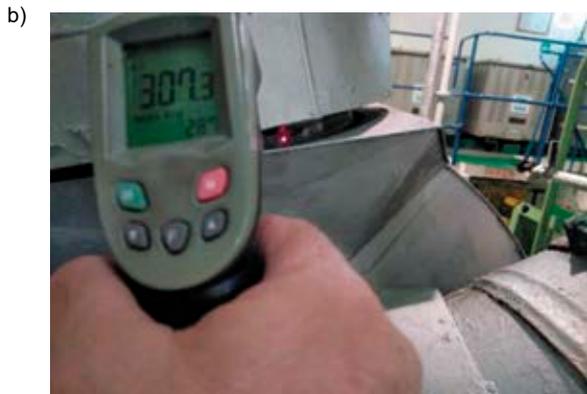
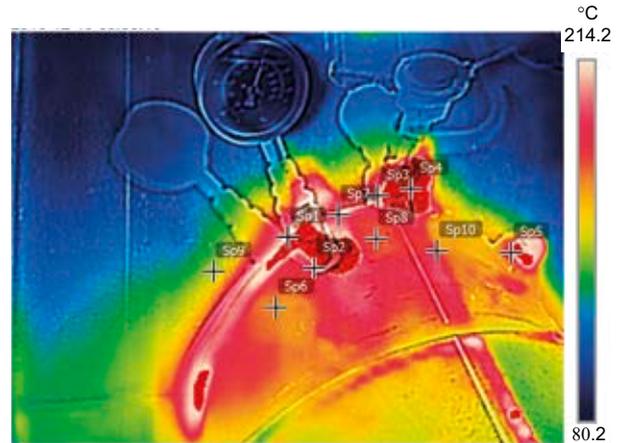
Figure 2a similarly shows the main engine exhaust system, where the FLIR showed values exceeding 150°C on the uninsulated bolted flange at the exhaust gas outlet from the turbocharger. The hybrid approach was thus applied (Figure 2b) to determine the exact temperature since values over 300°C are particularly hazardous. The temperature of uninsulated bolted flange at the exhaust gas outlet from the turbocharger was 307°C .

Figure 2. Uninsulated bolted flange at the exhaust gas outlet from the turbocharger: a) thermal map and b) infrared thermometer

Regular inspections of insulation and potentially dangerous uninsulated areas, particularly after any major overhauls, are recommended. In the observed cases, remediation was achieved using spray-coat insulation or insulating blankets, which are readily commercially available.

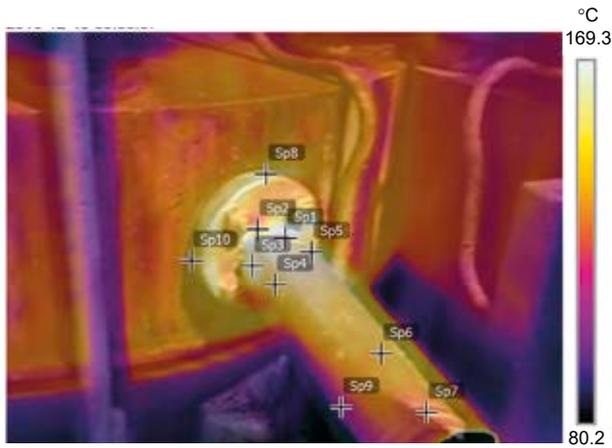
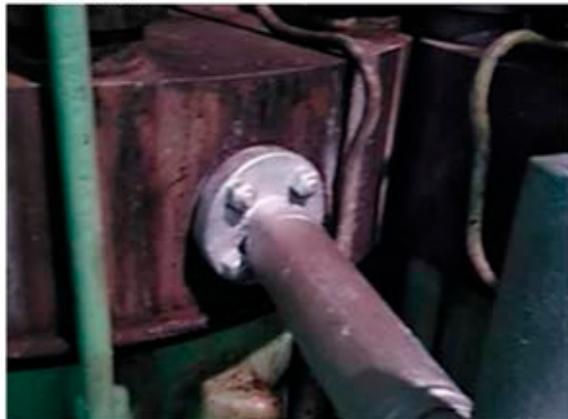
Figure 5 shows the ME cylinder indicator cock, which was 172°C, according to the infrared thermometer. High temperature values exceeding 200°C were also recorded on the ME collective exhaust manifold foundation bolts.

Figure 5. Thermal map of the ME cylinder indicator cock

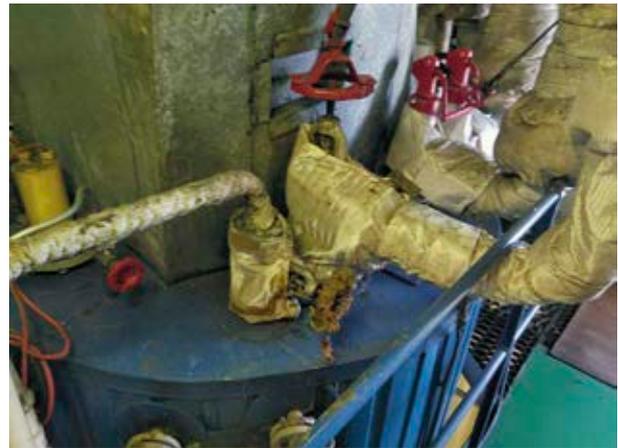
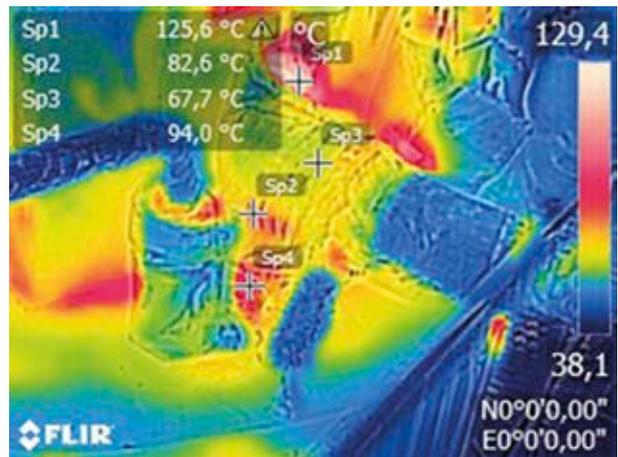
was manufactured by Messrs Aalborg Sunrod, and had a capacity of 1600 kg/h and a steam working pressure of 0.7 MPa. Figure 6 shows both the visual and thermal views.

All measurements were below the 150°C thermal camera threshold and were deemed only moderate risk.

Figure 6. VX boiler main steam valve: a) visual and b) thermal map

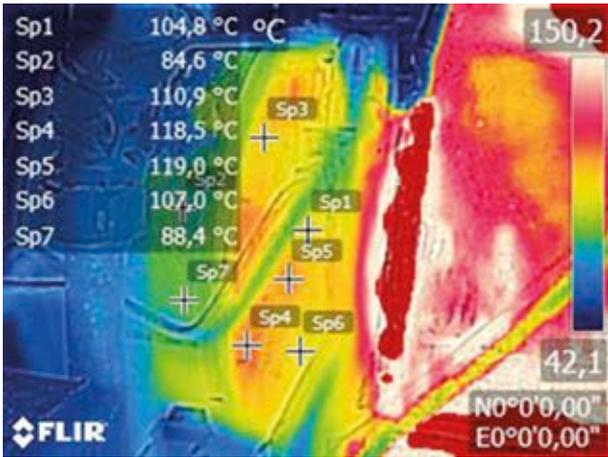
Figure 7 shows the turbocharger casing air inlet, with a temperature range of 84–118°C. The turbocharger gas outlet side (not pictured) ranged from 114°C to over 150°C. The infrared thermometer revealed a max temperature of 321°C. The bolted flange connecting the turbocharger exhaust gas port was 301°C. The turbocharger casing was 321°C, the exhaust gas manifold behind the turbocharger was 341.6°C, the flushing stub for turbocharger exhaust

Figure 7. Turbocharger casing temperature – air inlet side – thermal map

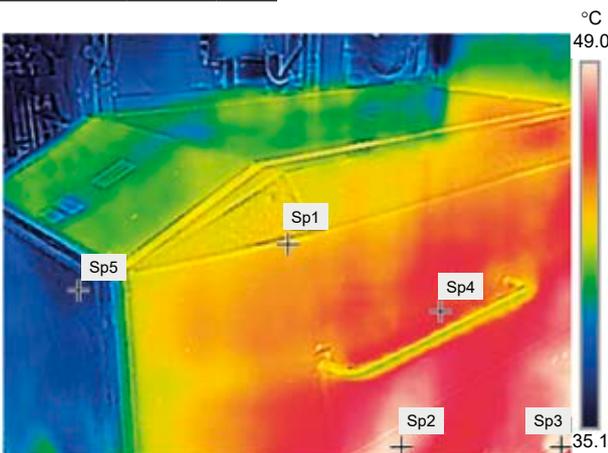
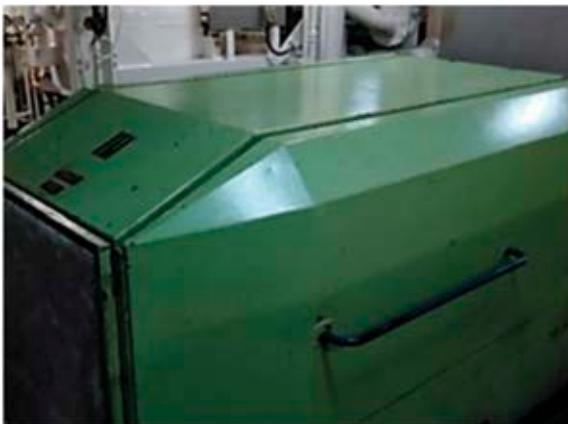
Sp1	43.2°C
Sp2	48.3°C
Sp3	55.0°C
Sp4	44.5°C
Sp5	37.7°C

Figure 8. Generator casing and FLIR Tools

Figure 8 shows the generator cover, with temperature of 37–55°C, making it low-risk.
