The use of an unmanned aerial vehicle to acquire data to develop inland electronic navigational charts: The case of a bridge and the navigation infrastructure located on it

Jacek Łubczonek

Maritime University of Szczecin, Chair of Geoinformatics
46 Żołnierska St., 71-210 Szczecin, Poland
e-mail: j.lubczonek@am.szczecin.pl

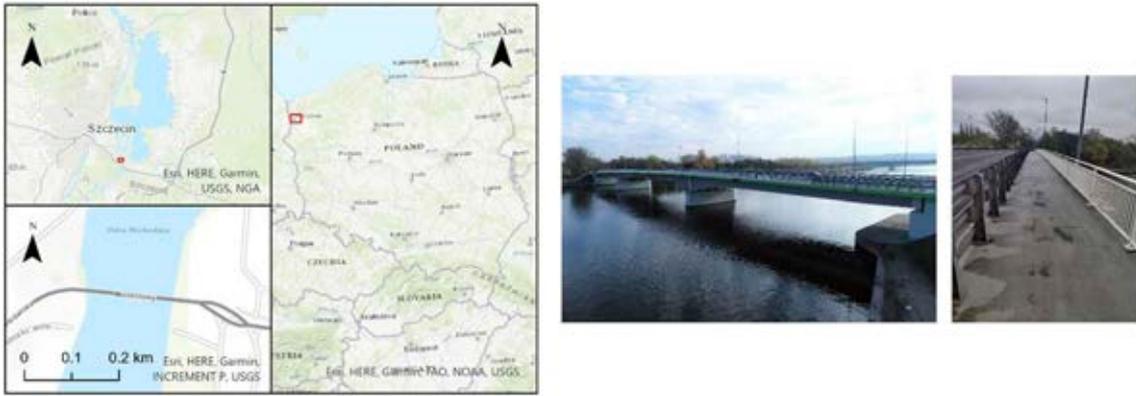
Figure 1. Location map of the bridge and view of the bridge and its elements: road safety barriers, railings, asphalt road, and pedestrian lane

The study area included a section of land with the Clowy Bridge. The bridge is located in Poland, in the city of Szczecin, on the Regalica River (Figure 1). The Clowy Bridge is constructed of two 100 m long steel segments supported on two pillars. The materials are reinforced concrete and steel. The roadway across the bridge is covered with asphalt, while the pedestrian lane is made of a hardened layer. This lane is separated from the road by a metal safety barrier. There are railings on the outer parts of the span. The view of the bridge is shown in Figure 1.

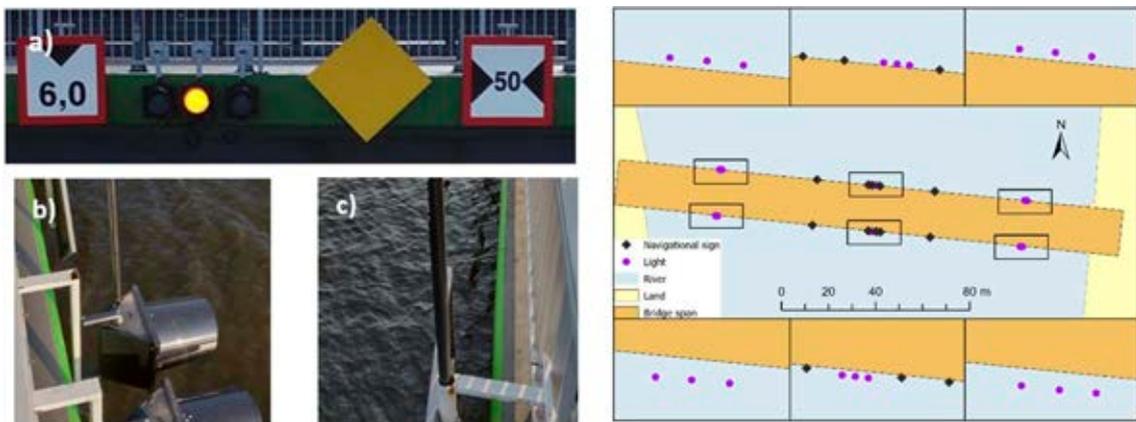
Figure 2. Objects used in the survey: a) Notice marks, navigation lights, and the side of the span (painted green), b) pole measurement of the lights, c) pole measurement of the notice marks. On the map: arrangement of lights, marks, and reflectors on the Clowy Bridge

Figure 2a, 2b, and 2c show the objects under investigation. Notice marks and navigation lights are attached to the bridge with brackets. In the case of the marks, the measurements were carried out

by inserting a pole through the holes in the bracket, while in the case of the lights, a pole was applied to the outer bolt. The span was measured by applying the pole to its outer edges. The location of the analyzed objects on the bridge span is illustrated in Figure 2.

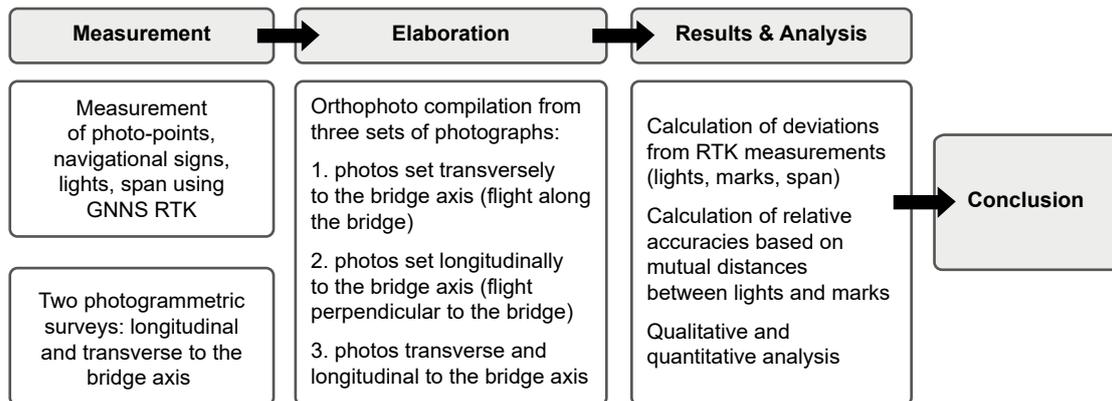
Figure 3. The research workflow

The research workflow (Figure 3) consisted of the successive steps of measurement, elaboration, results & analysis, and conclusions.

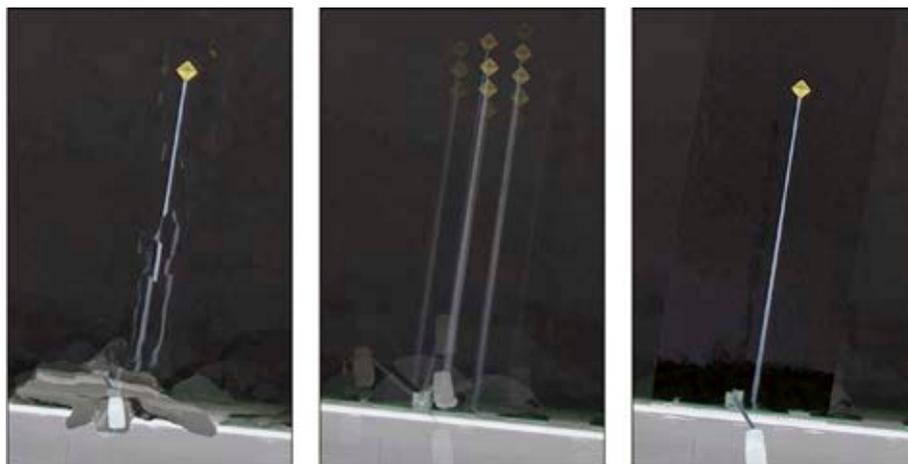
Figure 5. Local orthomosaic correction

During processing, based on visual inspection, a large amount of noise was found above-water near the banks and sides of the span, the lighthouses on the bridge, and the radar reflector mounts; therefore, this noise was filtered out manually and removed together with the lighthouse points and the radar reflector mounts due to their shuffling. The noise removal process affected the orthorectification result. Editing involved the local correction of a part of the image, especially the elongation of the span edge where marks and lights were fixed. Figure 5 illustrates the successive steps of orthoimage correction using the example of a streetlamp and radar

reflector. The first image, which was created with the system noise reduction option, shows very large distortions of the lamp and the reflector mount. Similar distortions for standing objects were also observed in the work in ref. (Koeva et al., 2018). On the other hand, removing this part of the DSM resulted in their replication in many places, known as the ghost effect (Xue, Zhang & Chen, 2021). These distortions were removed during the manual editing of the orthomosaics. The orthogonal projection options were chosen for the correction, which allows measurements to be made using the final product. Unfortunately, the image fragment in this projection was not always generated correctly; thus, such a process does not entirely allow the preservation of the correct geometry of the photographed objects. Such editing was also necessary when the light was obscured by a streetlamp. This made it necessary to take additional images from land or oblique images from the UAV to ensure that all objects were quantitatively identified to ensure the completeness of the mapped objects.

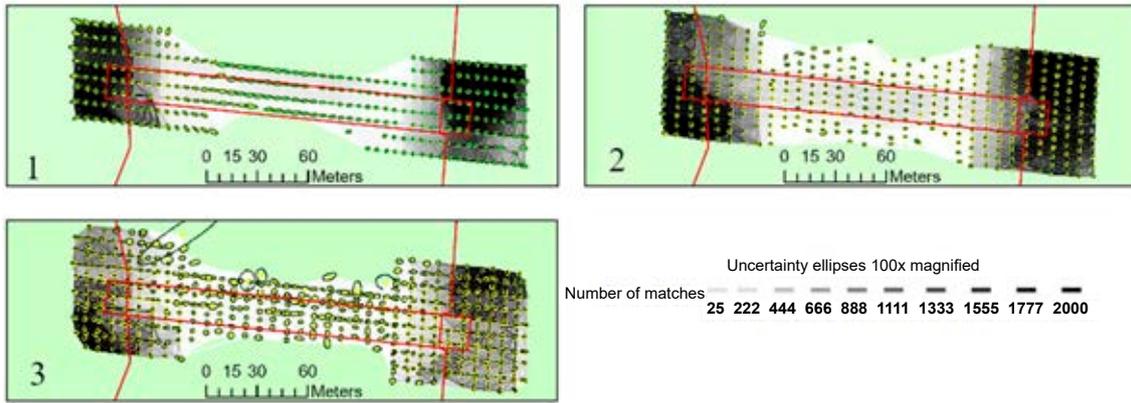
Figure 6. Match distribution and uncertainty ellipses for image sets 1, 2, and 3

In addition, the software could be used to analyze the quality of the matching based on uncertainty ellipses (Figure 6), which tend to be larger at the edges of the image block and smallest in the middle.

As can be seen, such a relationship occurred in the second set of images. The uncertainty ellipses for the first set of images were larger on the bridge span due to the processing of the data as two separate blocks of images. In the case of the third set of photos, their shapes were irregular, including the occurrence of large uncertainty ellipses, which indicates problems with the merging of the photos in the whole block. Some of the uncertainty ellipses were located in the centers of the projection of the photos over water. Nevertheless, the ellipses have different sizes on the bridge span, indicating problems with matching them. In addition, the merged set of photos eliminated the problem that occurred with photo set 1.

Another element of the analysis is the number of image matches. The minimum number of matches is 25, while the optimum is more than 1000. Analyzing the maps of matches shows that in all cases, the number of matches decreased significantly at the span of the bridge. Both cases are illustrated in Figure 6. For image sets 1 and 3, the number of matches was very small – about 25. The best case was image set 2, where the number of matches ranged from 25 to 222.

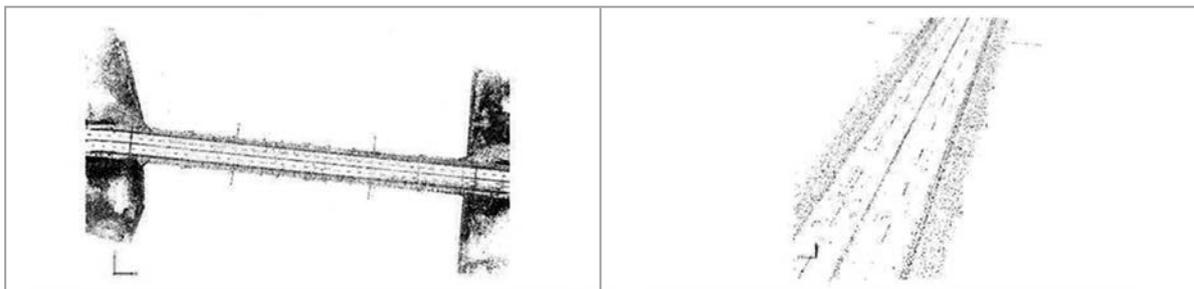
Figure 7. The view of tie points

In the cases analyzed, the location of the tie points is also interesting. The fewest points were located on the asphalt roadway. A greater number of them were observed on horizontal markings, which is certainly an advantage for this type of facility. A much larger

number of tying points were located on pedestrian walkways, road safety barriers, and fewer on the railings. The highest number of tie points was in the land area of the study, which has a varied structure, causing many tie points to be generated. A view of the generated tie points is illustrated in Figure 7.

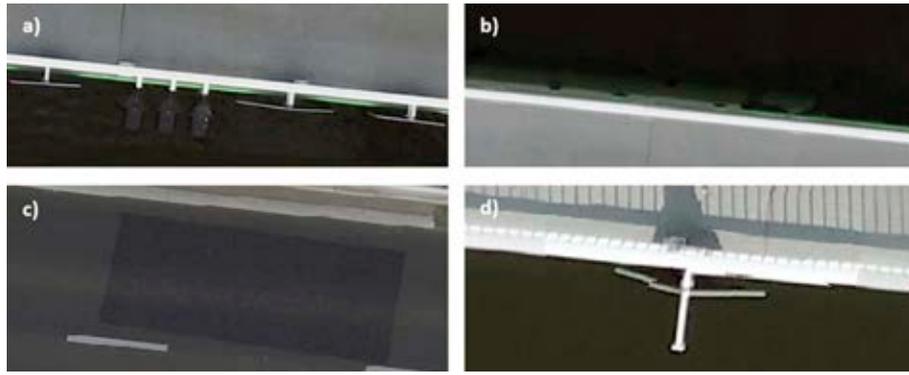
Figure 8. Analyzed cases of qualitative assessment: a) lights and marks, b) edge of the bridge span, c) effect of car removal, and d) uncorrected object with a broken sign effect

The final orthophoto product was highly detailed and of good quality. Marks and lights could be identified from the image, along with the measurement points (Figure 8a). It was also noticed that the span edge was not very well represented – in some places, it was not clearly marked and had slight artefacts (Figure 8b). Additionally, after local correction of the orthophoto fragments, the effect of patches was noticed, which affected the aesthetics of the final work (Figure 8c). In some cases, it was not possible to select a suitable orthophoto for local correction, so hence the object was not reproduced correctly in its entirety (Figure 8d). The continuous lines of the horizontal markings were mapped correctly, which also demonstrates the correctness of the orthomosaic generation. Undoubtedly, the final product meets the technical requirements in terms of the identification

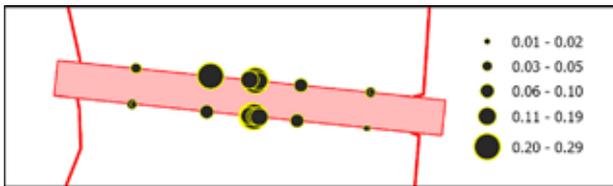
Figure 9. Signature map of deviations (cm) from marks and lights for set no. 1

Based on the results in Table 3, it can be concluded that the best results were obtained for datasets 2 and 3. The mean errors had values up to 6 cm and maximum errors up to 12 cm. Dataset 1 showed the highest maximum error of 29 cm. In terms of relative accuracy (Table 4), the highest value of the mean error was 5 cm in all cases. The highest maximum errors were recorded for measurement set 1. Analyzing the magnitude of the errors along the bridge span, it can be concluded that they do not show much dependence on the number of tie points or specific parts of the bridge. Some regularity was noted in case no. 1 (Figure 9), where larger errors occurred in the middle part of the span. For the second set of measurements, larger errors occurred on

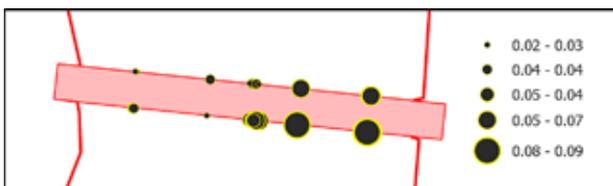
Figure 10. Signature map of deviations (cm) from marks and lights for set no. 2

the right side of the span (Figure 10), and for set no. 3, their magnitude varied (Figure 11).

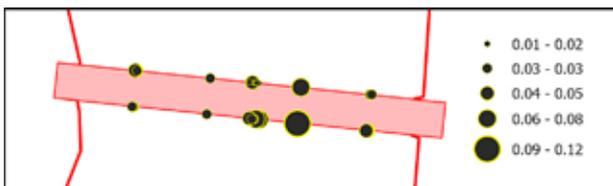
Figure 11. Signature map of deviations (cm) from marks and lights for set no. 3

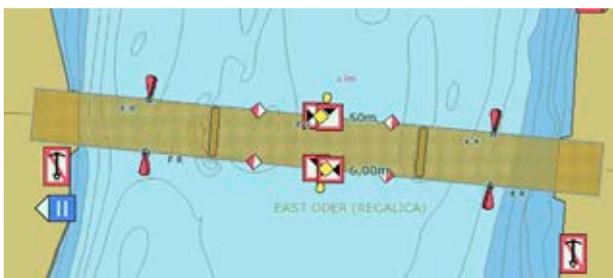
Figure 12. Mapped marks, lights, and span on the IENC map

Figure 12 shows a map with vectorized marks, lights, and bridge span as elements of an electronic navigational chart for inland navigation.
